120-inch Water Main Break (WMB) MI-ACE 23

120-inch Water Main Break Largest size transmission main in GLWA system

- 4:30am on Saturday, August 13, 2022
- 23 communities impacted
- 935,000 estimated people
- One business in Greenwood
- One business in Imlay Township
- BWA issued

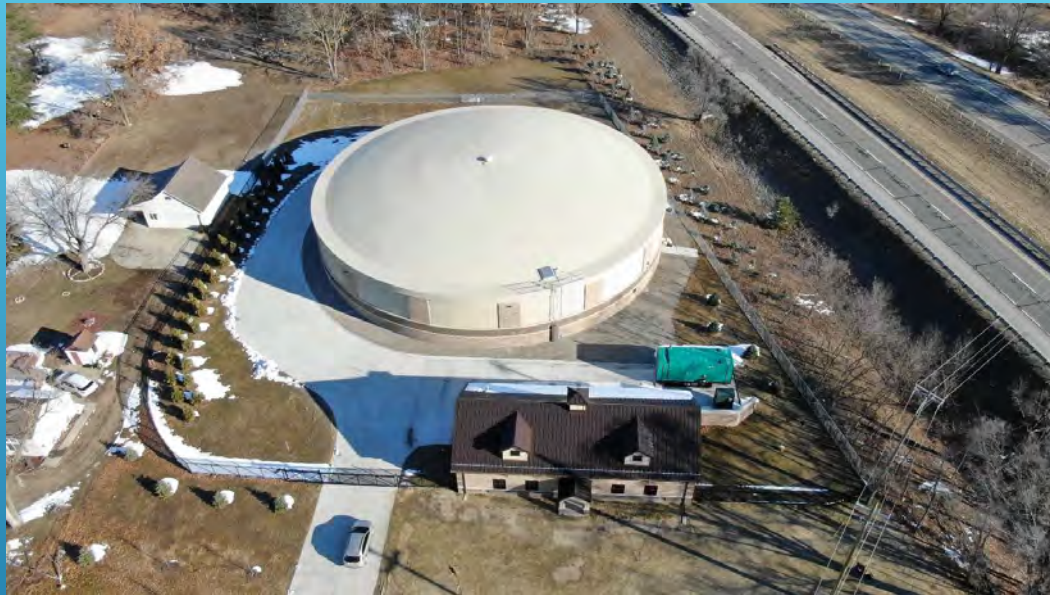
3.5 Million Gallon
Storage Facility

Put into service
4/1/2022

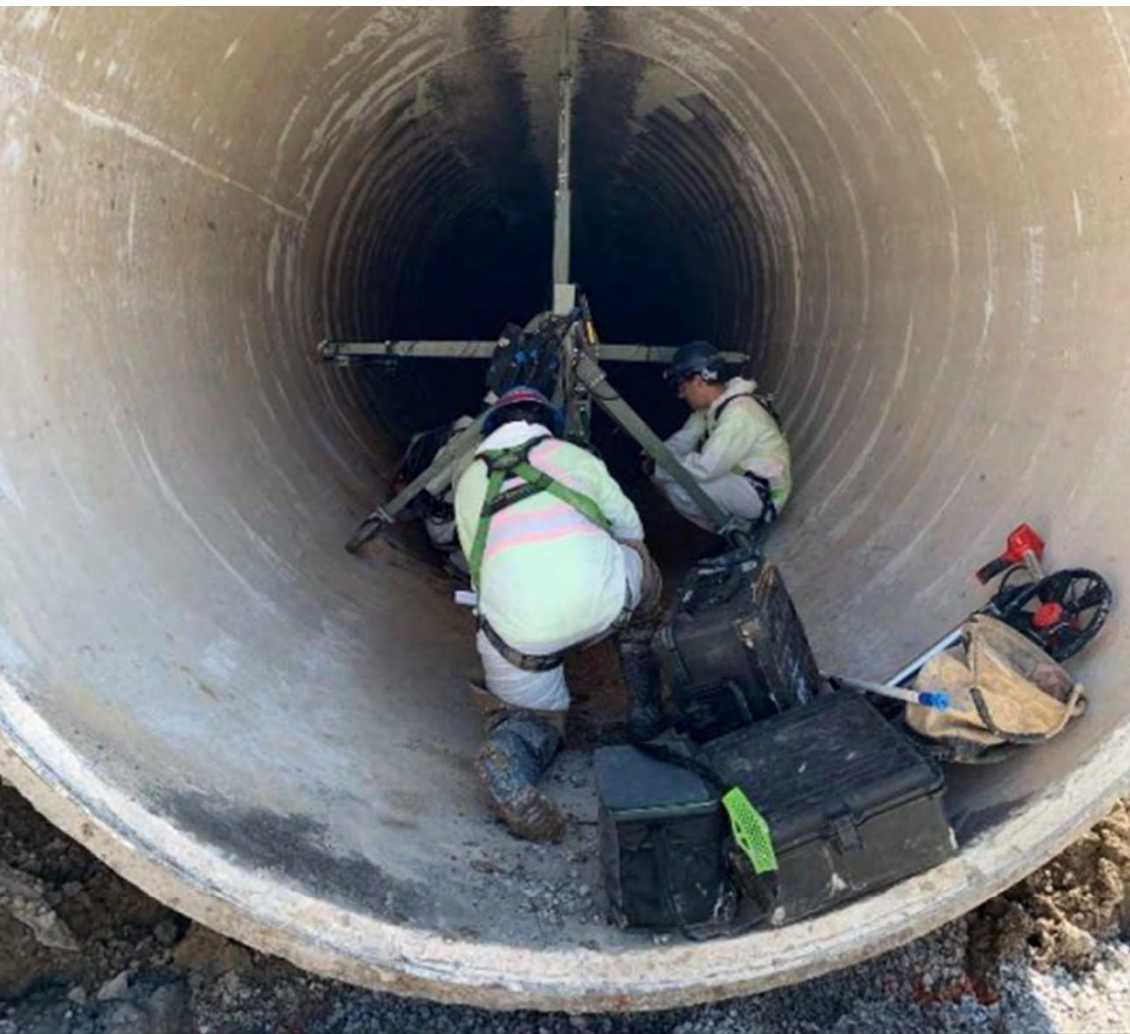
Figure 6. PICA crew completing the assembly of the NFT tool during the inspection of the East leg.

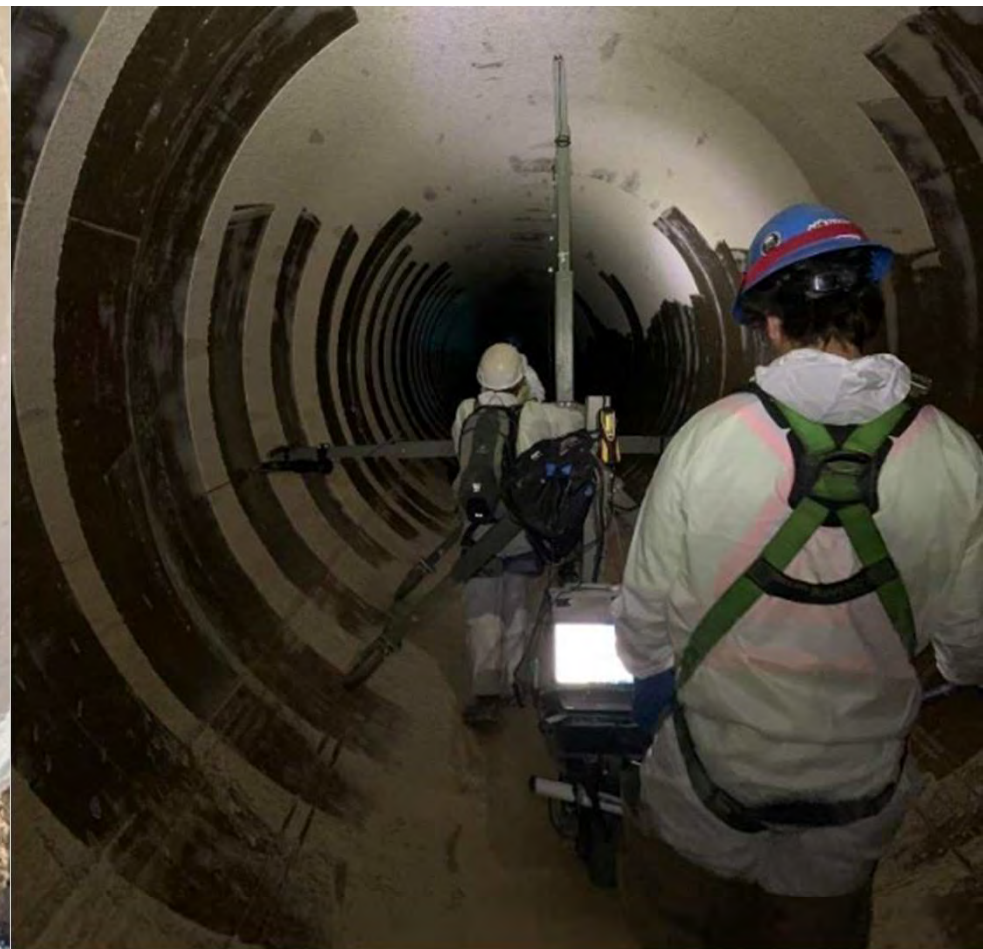
Figure 7. PICA operator monitoring the EM data as it's collected during the August 2022 NFT inspection of GLWA's 120-inch PCCP Transmission Main.

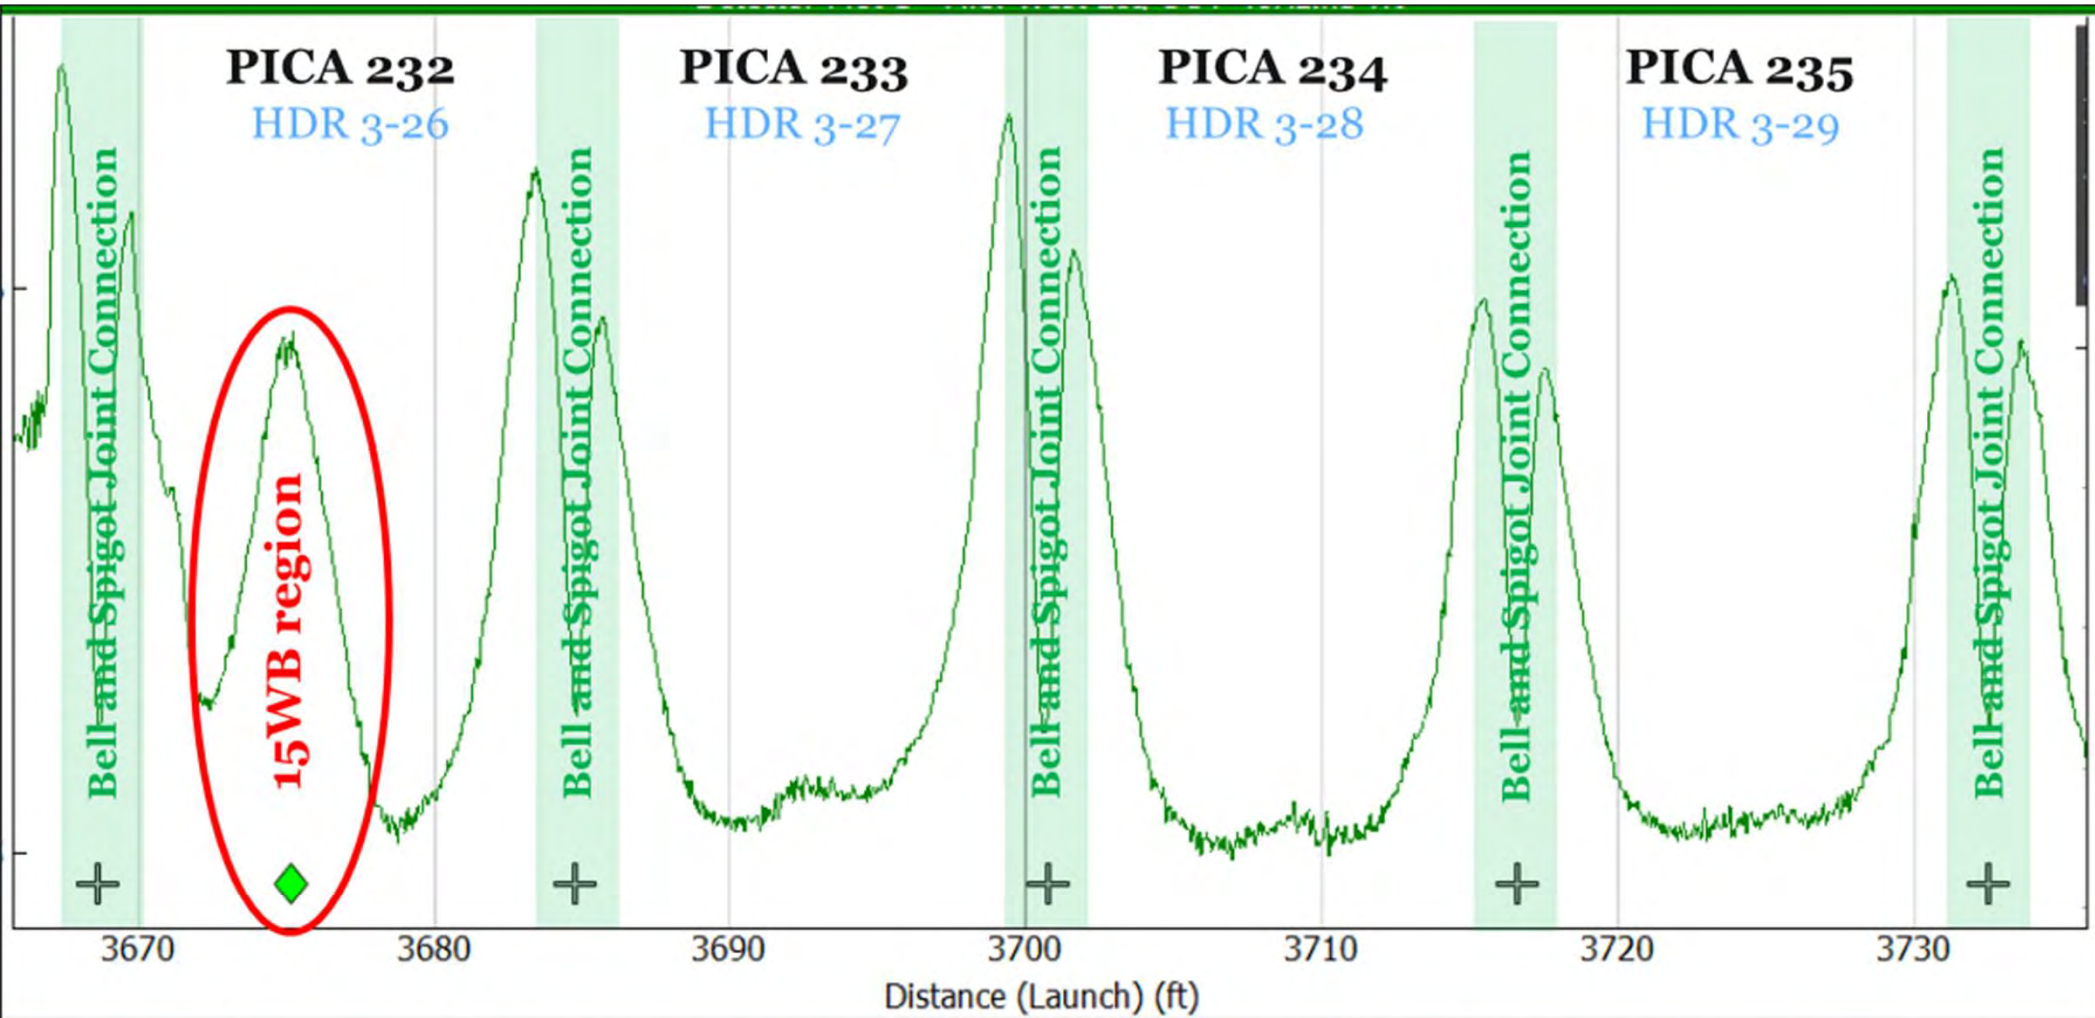
Figure 8: Electromagnetic (EM) data (phase) capture highlighting the 15WB region detected in Pipe 232 (HDR Pipe 3-26). EM data for neighboring Pipes 233, 234 and 235, which did not contain any wire breaks, were included as baseline references.
