# *Minnesota Asphalt Conference*

## **Micro Milling Combined with Thin Pavement Surface Treatments - MnDOT's Experience**

*Joel Ulring | Pavement Preservation Engineer  
Office of Materials and Road Research*

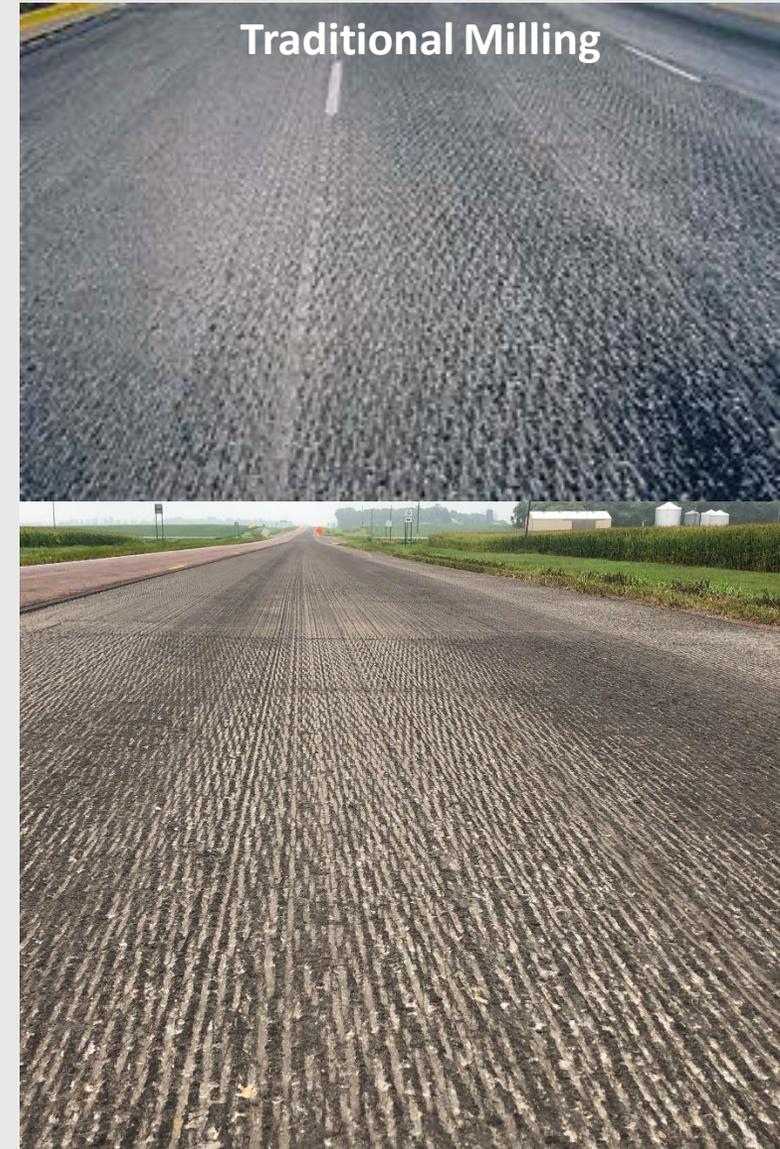
## Three types of milling:

- *Traditional Milling – Teeth spaced 0.625 inch ( $\approx 5/8$ " )*
- *Fine Milling – Teeth spaced 0.3125 inch ( $\approx 5/16$ " )*
- *Micromilling – Teeth spaced 0.200 inch ( $\approx 3/16$ " )*  
*(About three times the teeth on a traditional milling drum)*

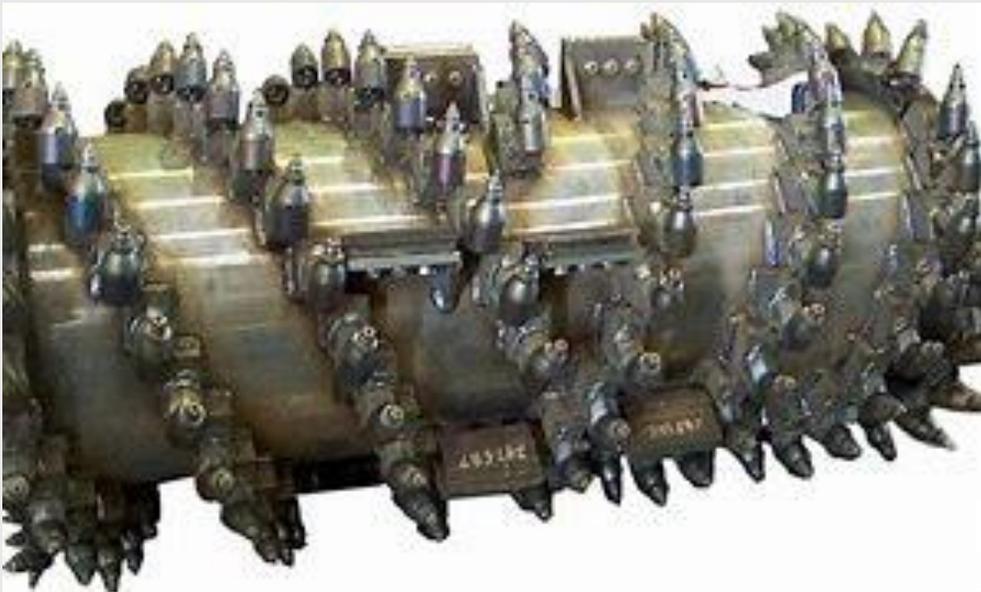
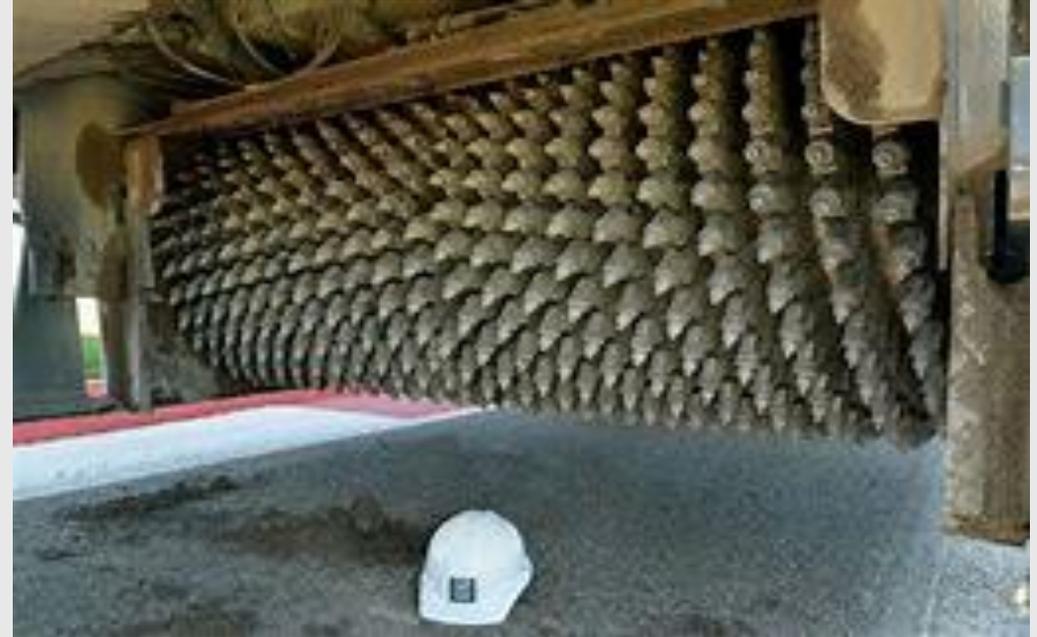
Traditional Milling Head

Micromilling Head

*A micromilling head has about 3 times the number of milling teeth or points.*

*It has a tighter lacing pattern which creates a smoother finished surface.*

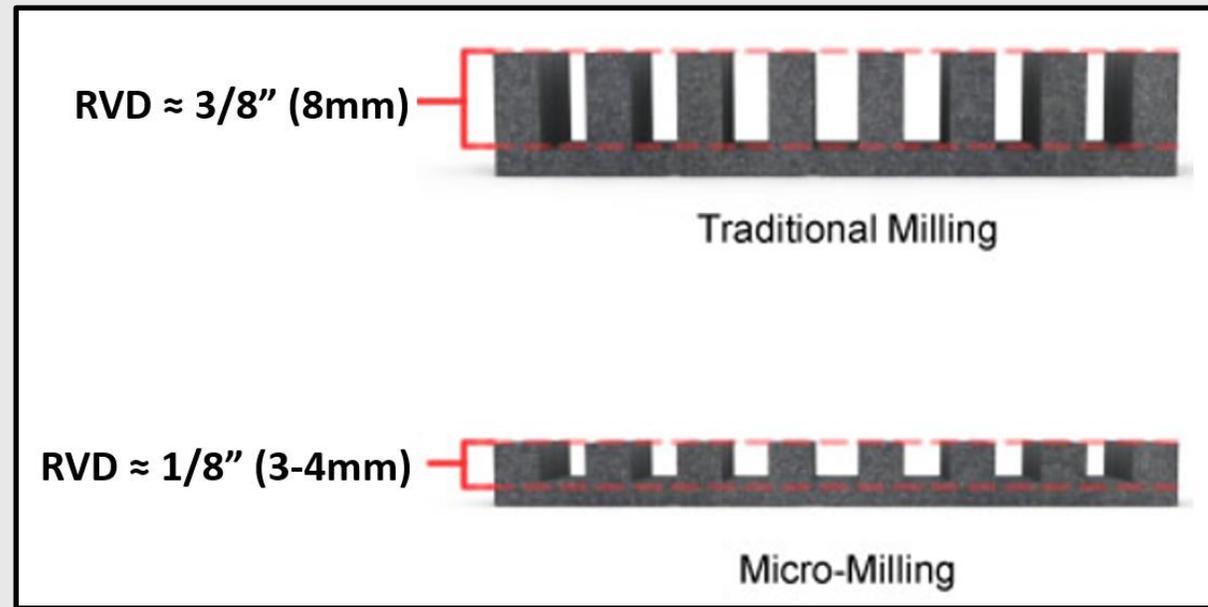
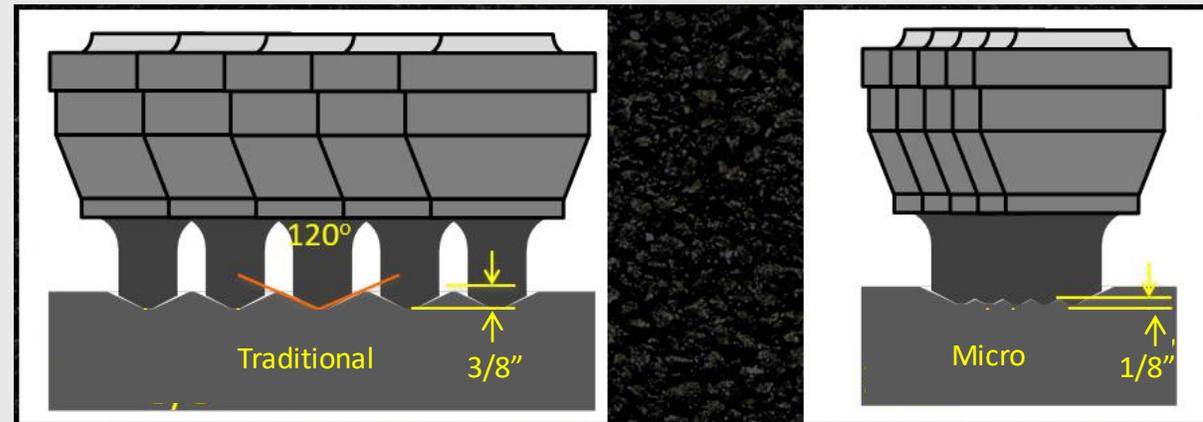
## ***Micromilling has a lower Ridge to Valley Depth – RVD***

- *RVD is the height difference between the lowest and highest points of the milled surface.*
- *Used to characterize a milled surface.*
- *Important when placing thin surface treatments.*

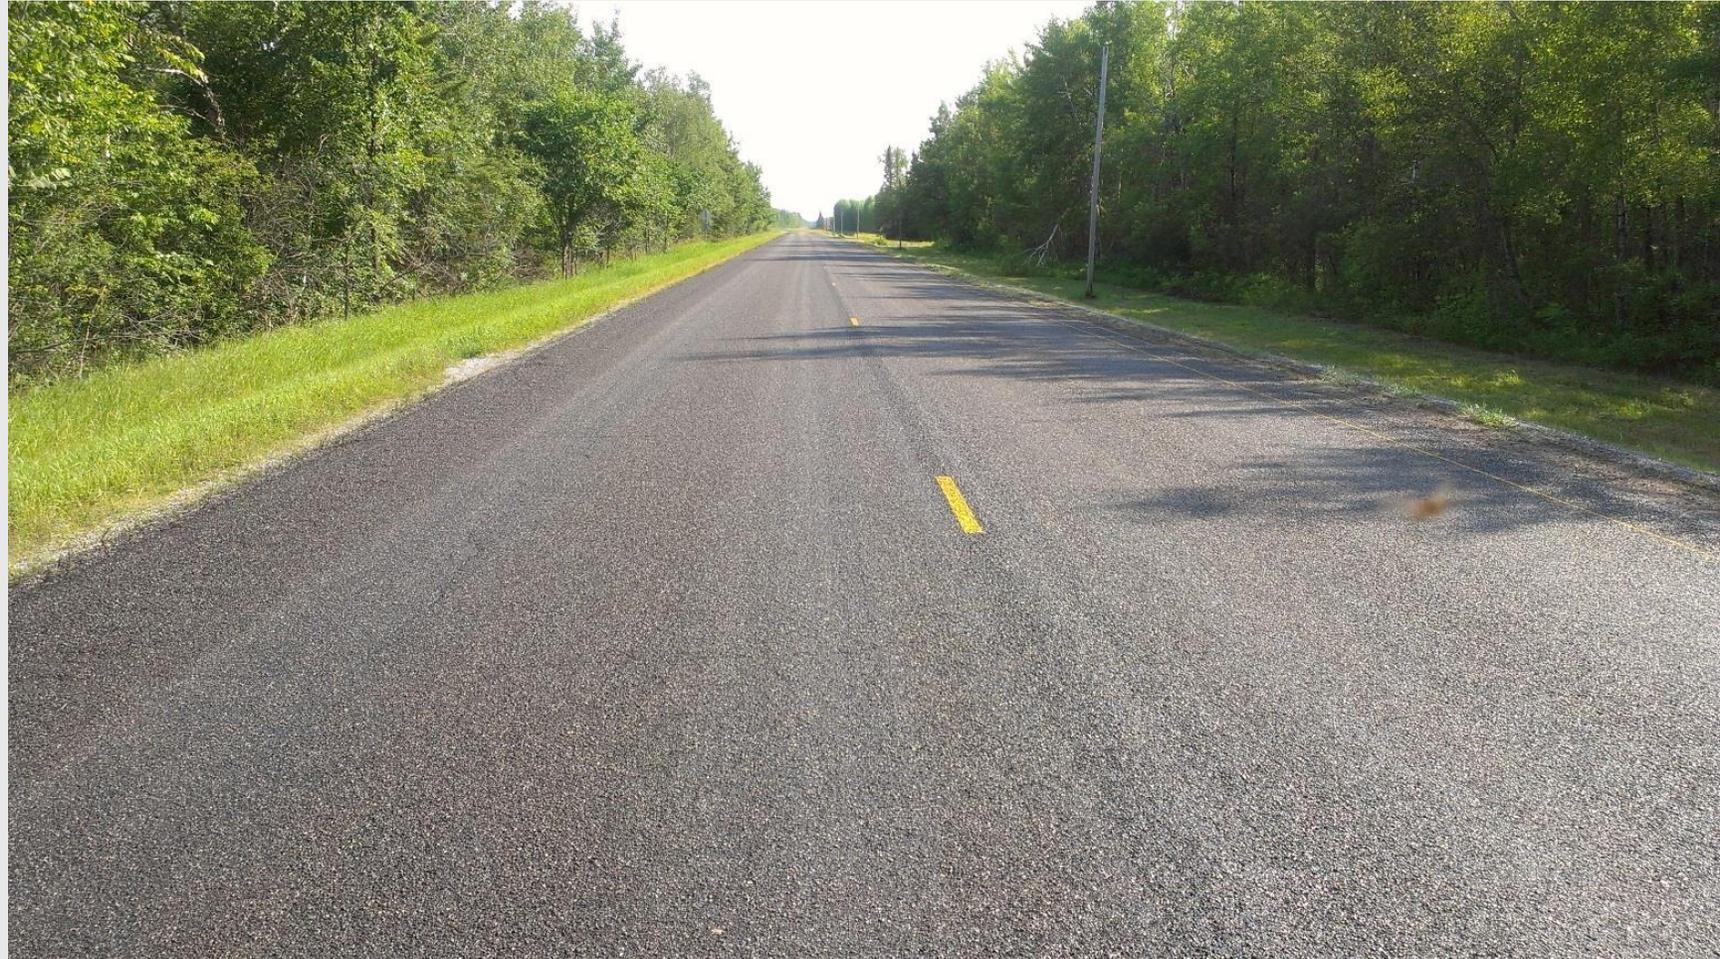
TH 89: After Chip Seal with Micromill (2013)

- TH 89 Grygla, MN (2013)
- TH 9 Breckenridge, MN (2014)

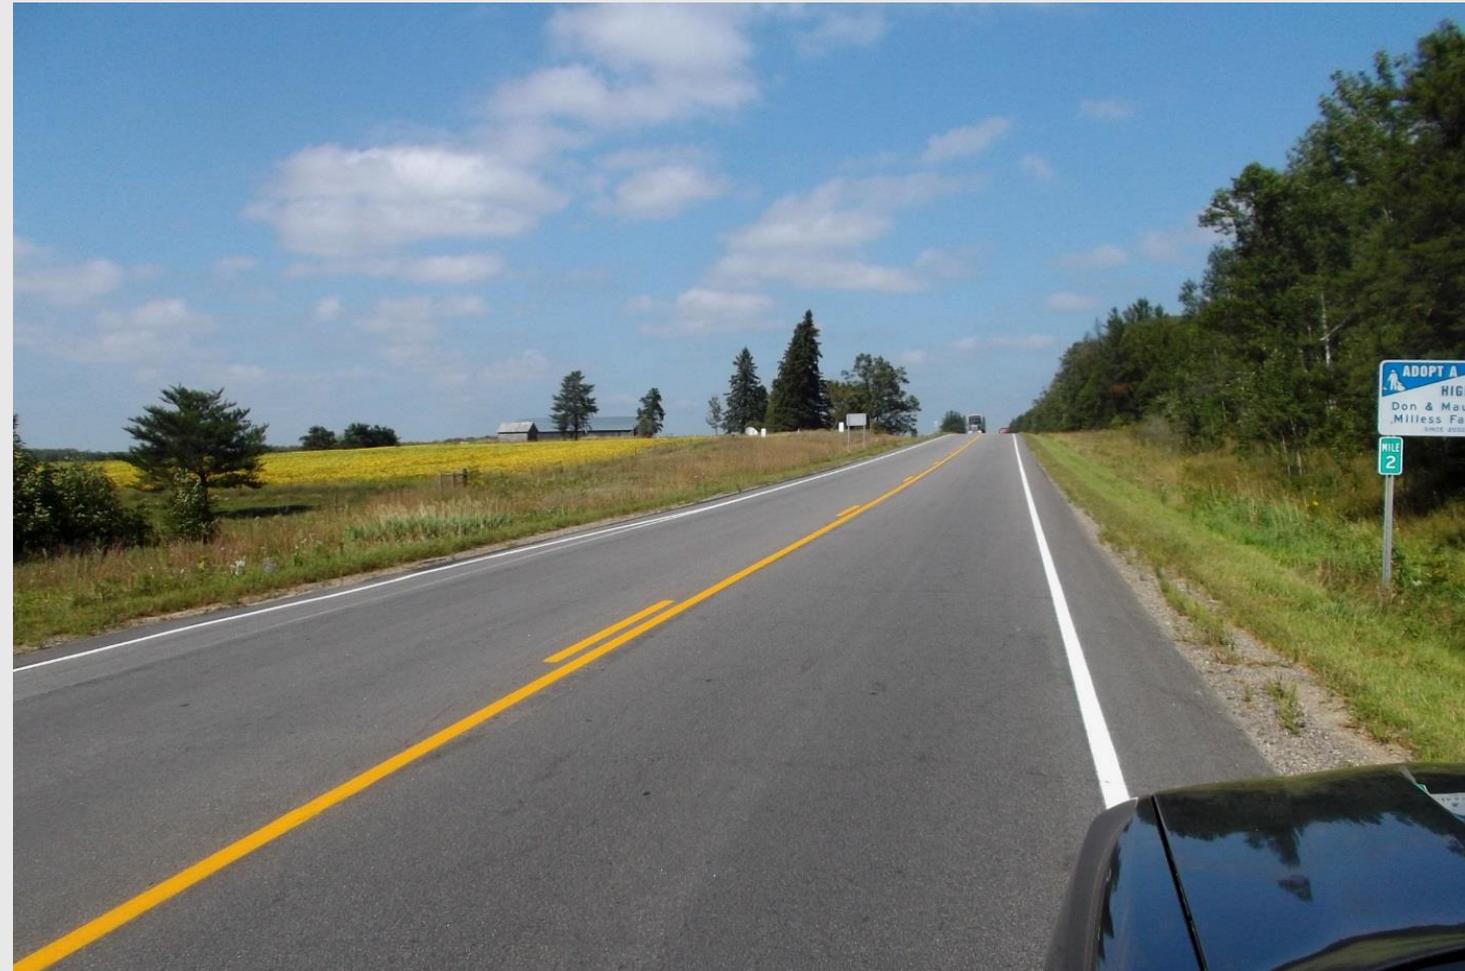
TH 64 One Year (2015) After Micromill & Micro-surfacing

- TH 64 Motley
- TH 12 Willmar
- TH 10 EB New York Mills

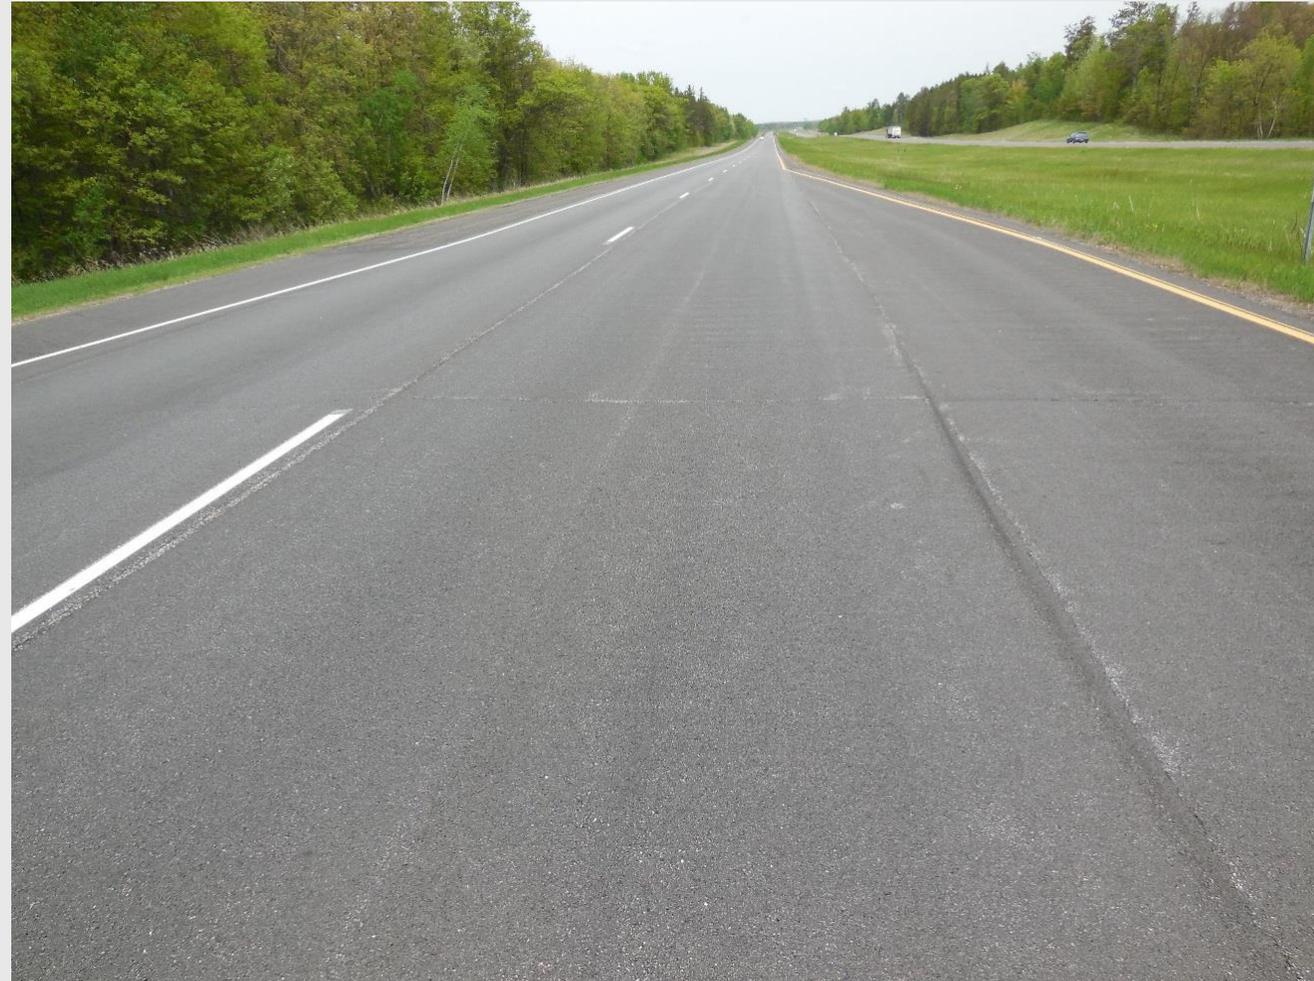
US 10 After Micromill & UTBWC

- US 10 Motley
- I-394 Hwy 100 to I-494

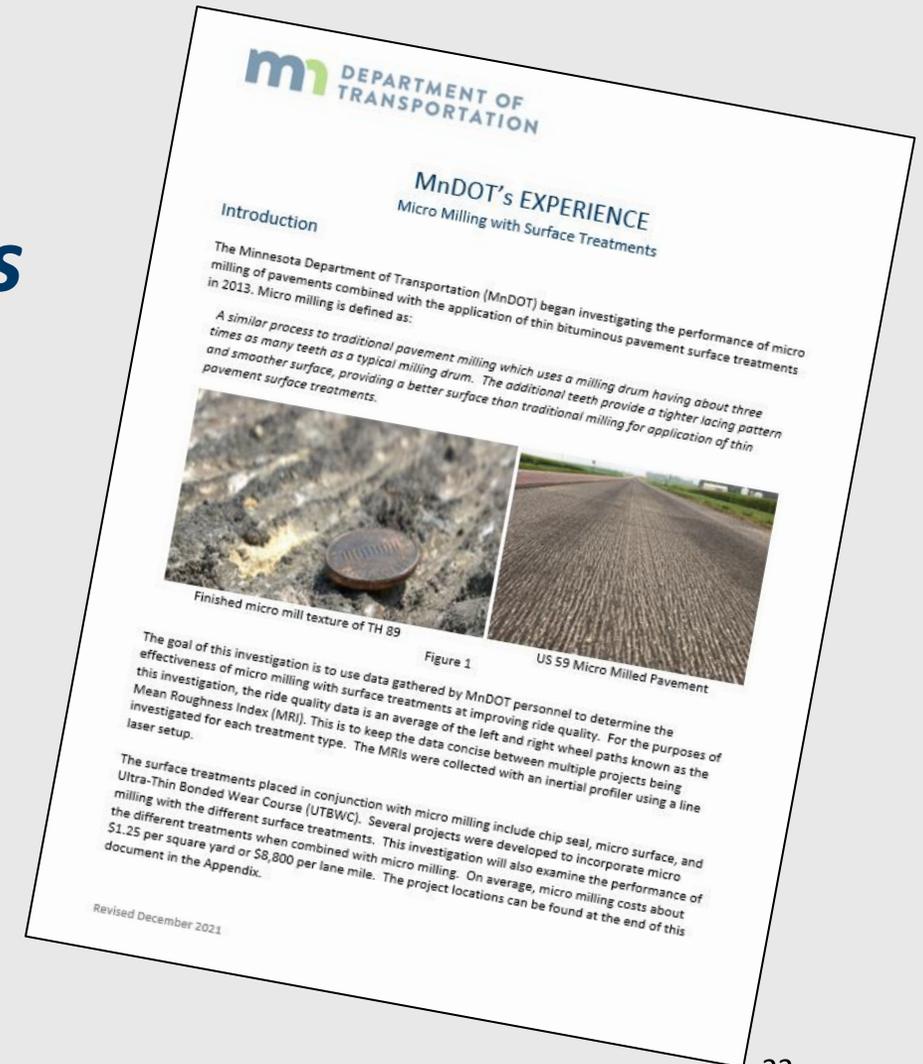
## *MnDOT's EXPERIENCE* *Micro Milling with Surface Treatments*

- Updated annually
- Located on MnDOT's Pavement Preservation web page under Reports

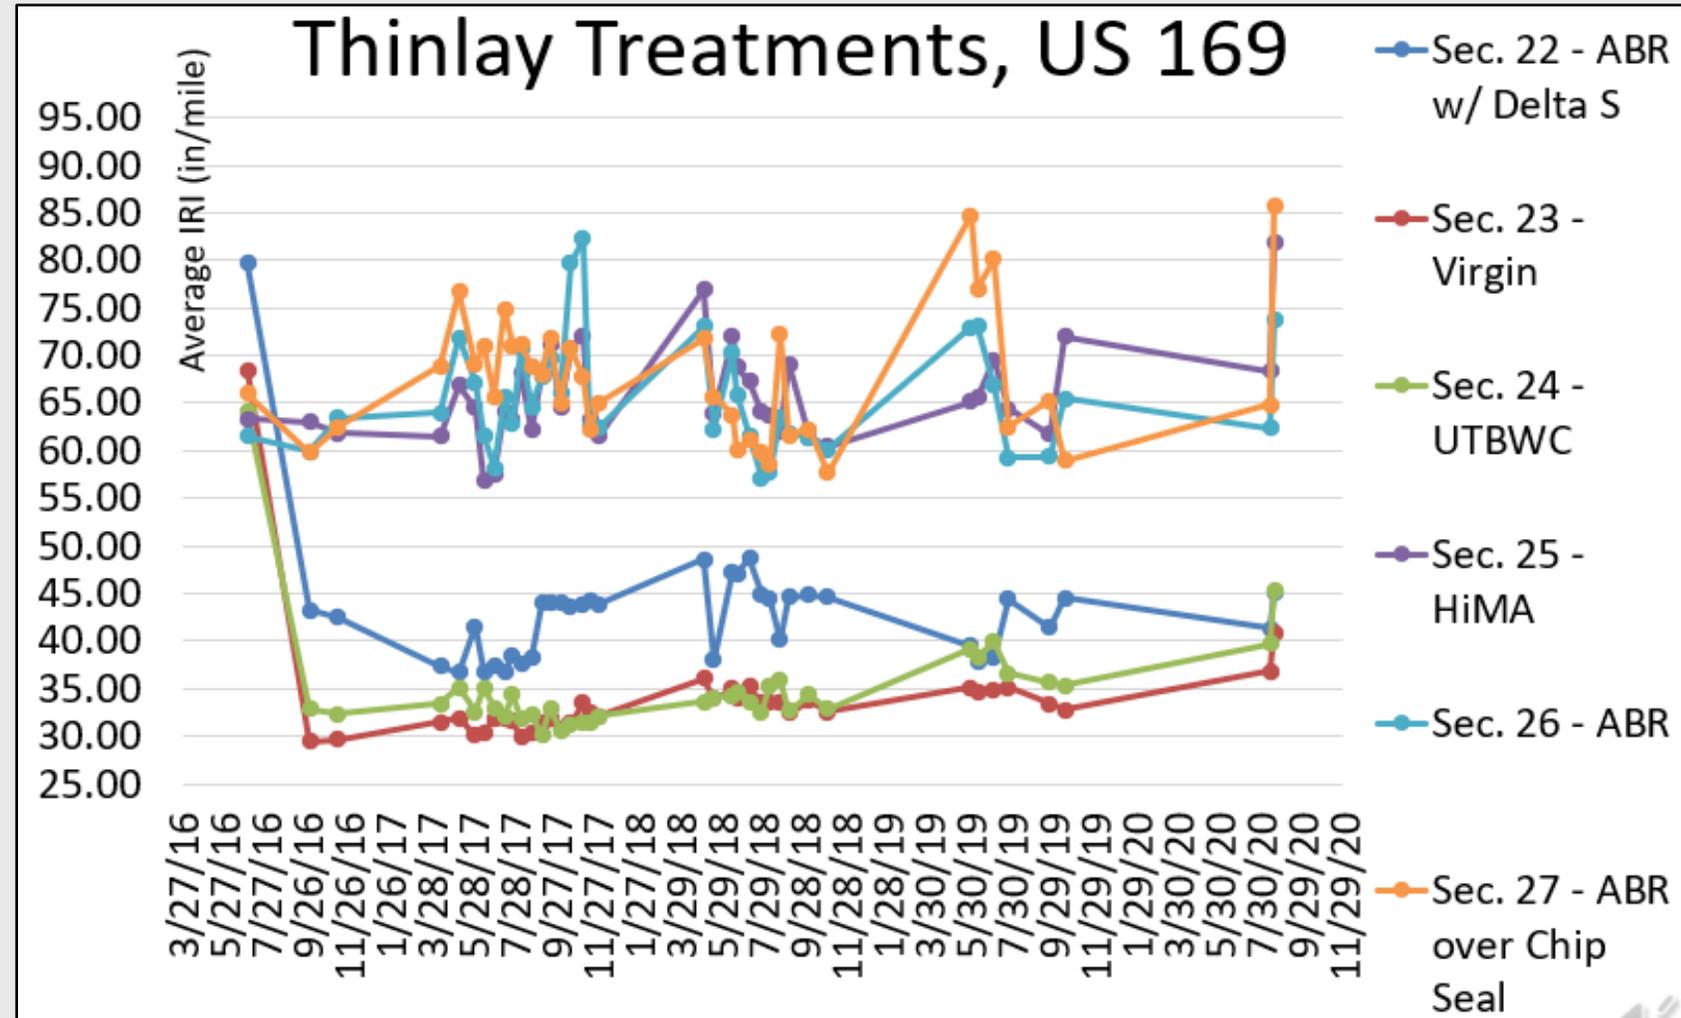
- Sections 22, 23 & 24 were micromilled with a machine fitted with a 12' wide milling head.
- Sections 25, 26 & 27 were micromilled with a machine fitted with a 7' wide milling head.
- ABR – Asphalt Binder Replacement can be a rejuvenator, RAP, RAS, etc.

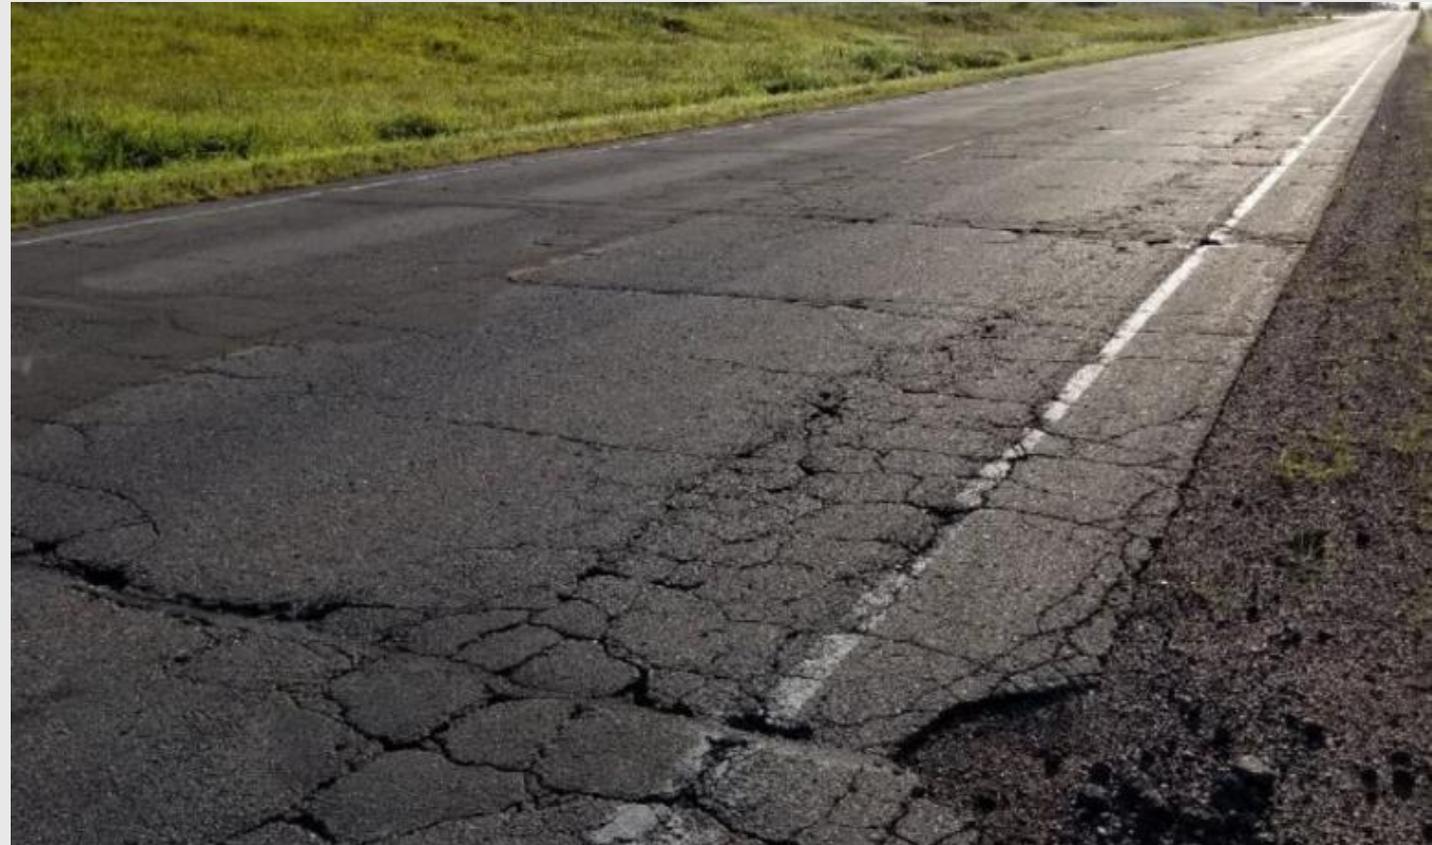
### Existing Conditions

- EB – Albertville, MN
- WB – Otsego, MN
- About 1 mile segment
- IRI = 270's to 420's inches/mile
- Existing section
