Fiber Reinforced Asphalt

Joseph Yaede, PE

Pacific GeoSource - Senior Pavement Engineer

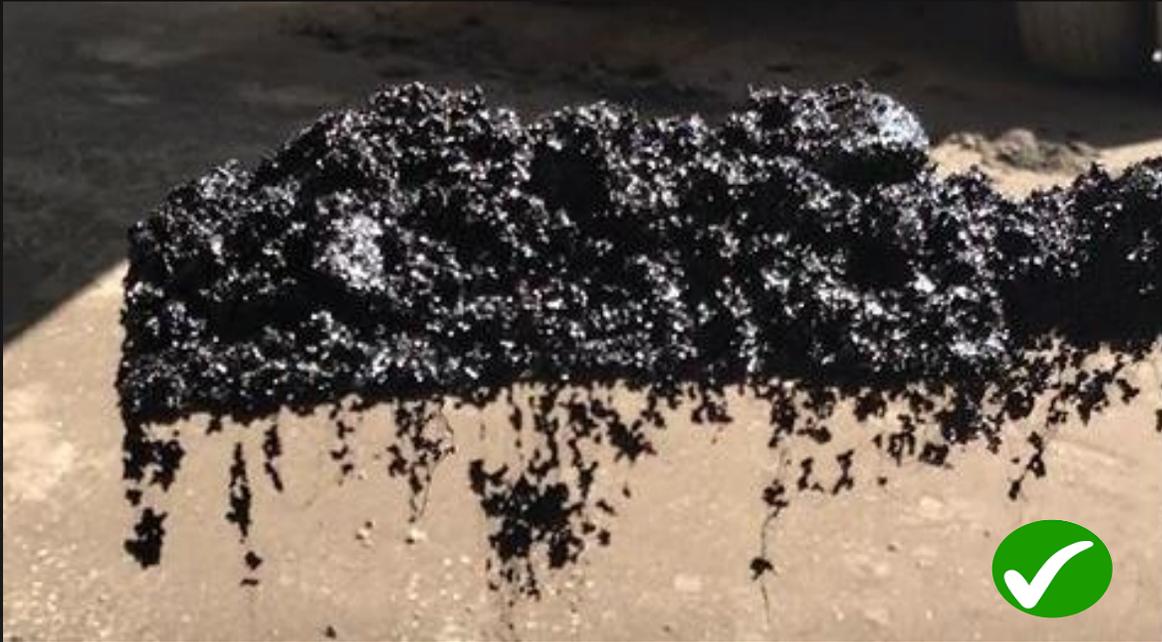
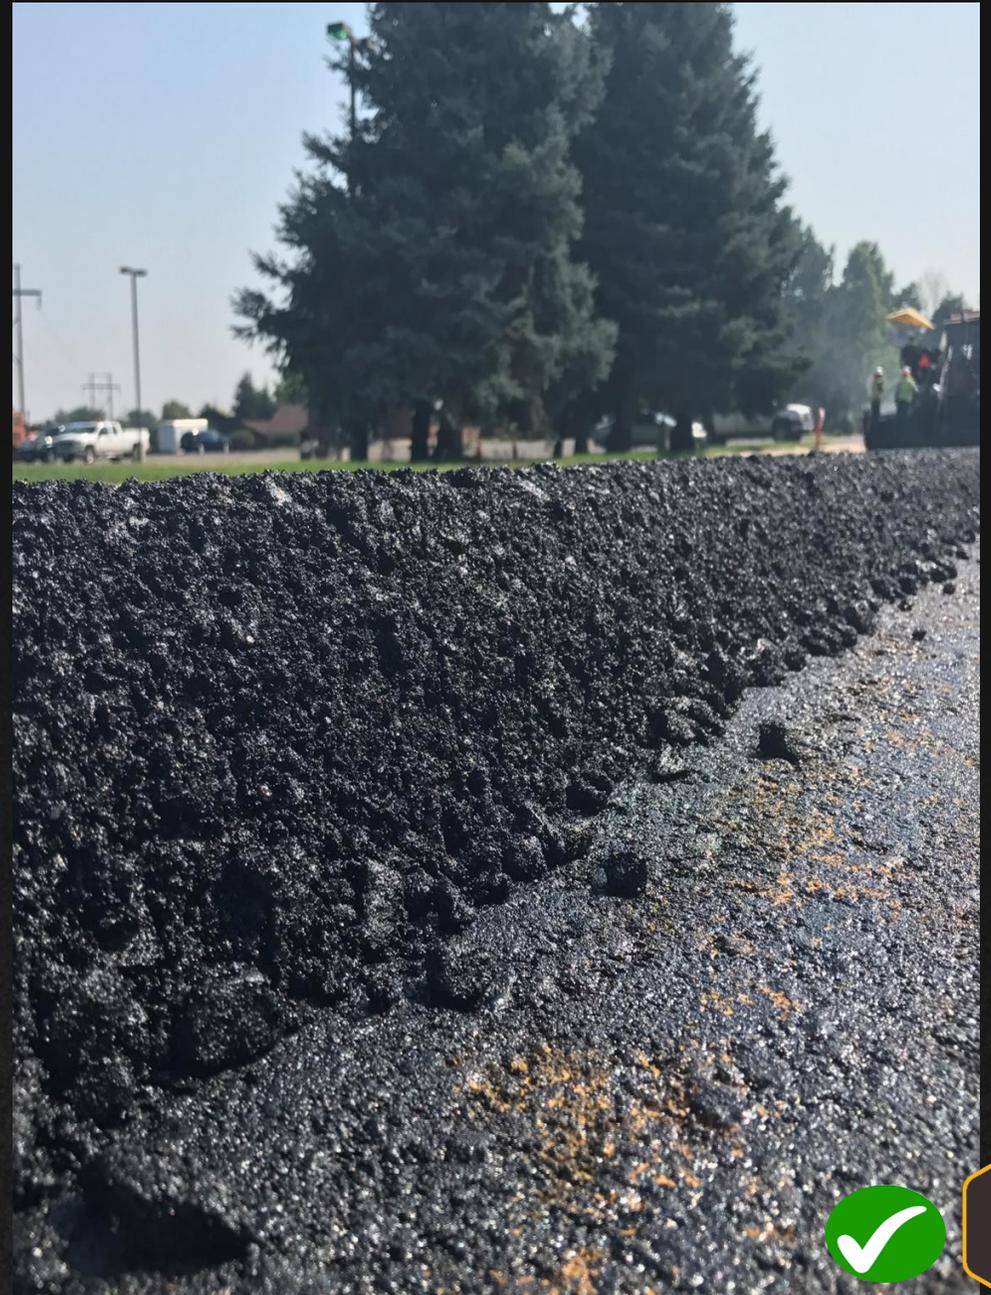
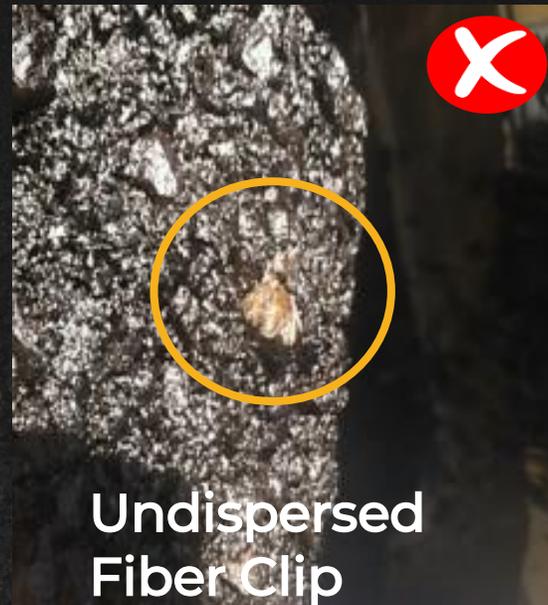
How Does Fiber Reinforced Asphalt Work?

- 1) Strength (Aramid & Polyolefin)
- 2) Distribution & Dispersion
- 3) Micro-Fibrillation

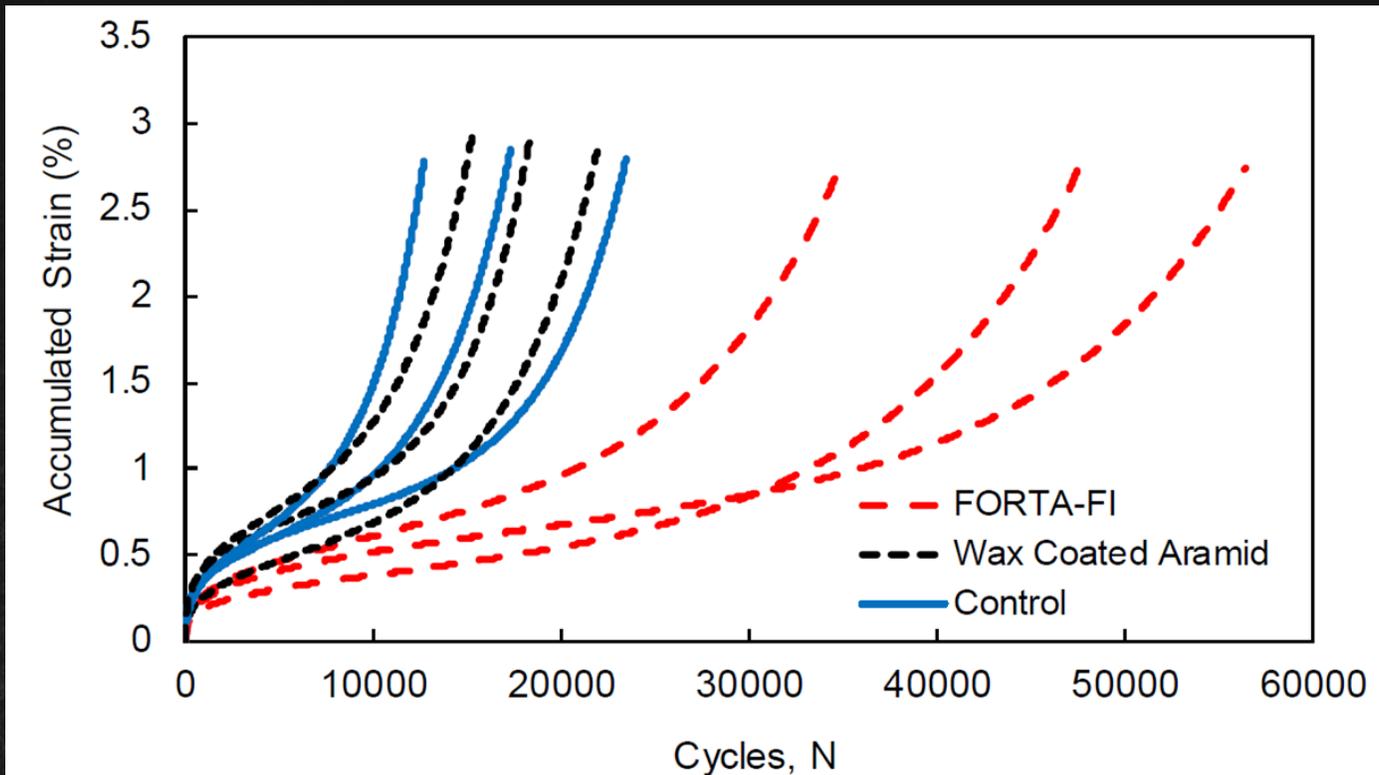
Rutting: Flow Number

Image: Noorvand, Hossein, et al. "Effect of Synthetic Fiber State on Mechanical Performance of Fiber Reinforced Asphalt Concrete." *Transportation Research Record* (2018).

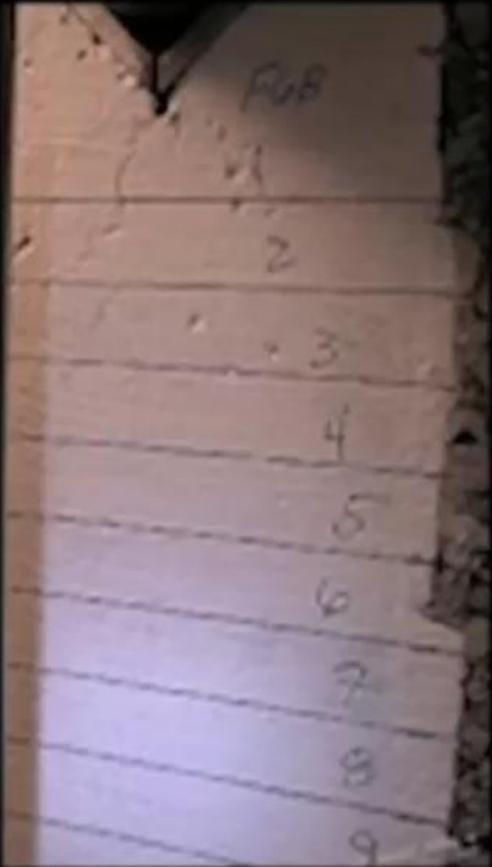
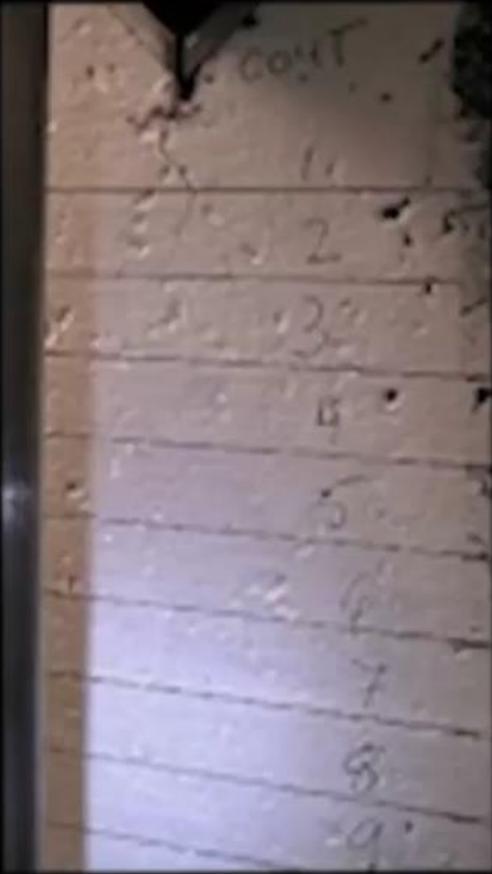
Cracking: C* Line Integral

Crack Length Time

Loading Rate: 0.9mm/min. Test Temp 21C

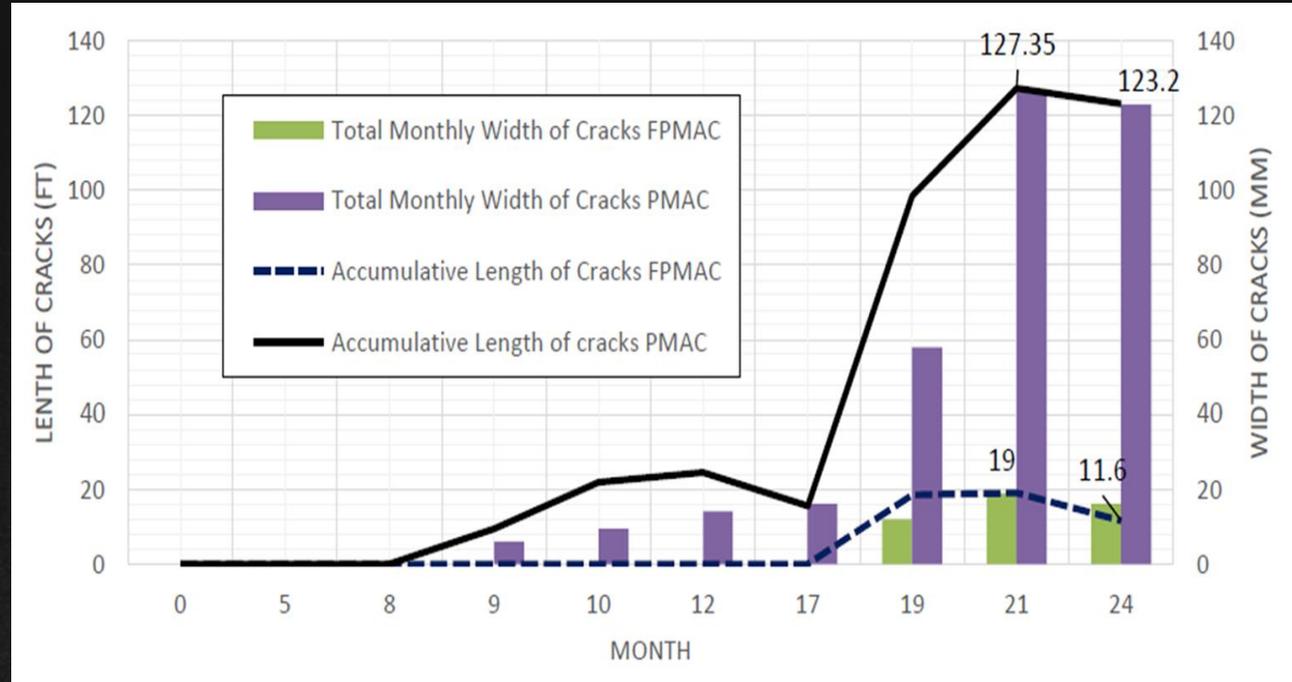
Havasupai Rd

- 2" Mill & Overlay - PG 76-22 TR+
2 Year Evaluation
200 Freeze-Thaw Cycles a Year (7000 ft)
- Total Crack Length
Control: 127' FORTA-FI: 19'

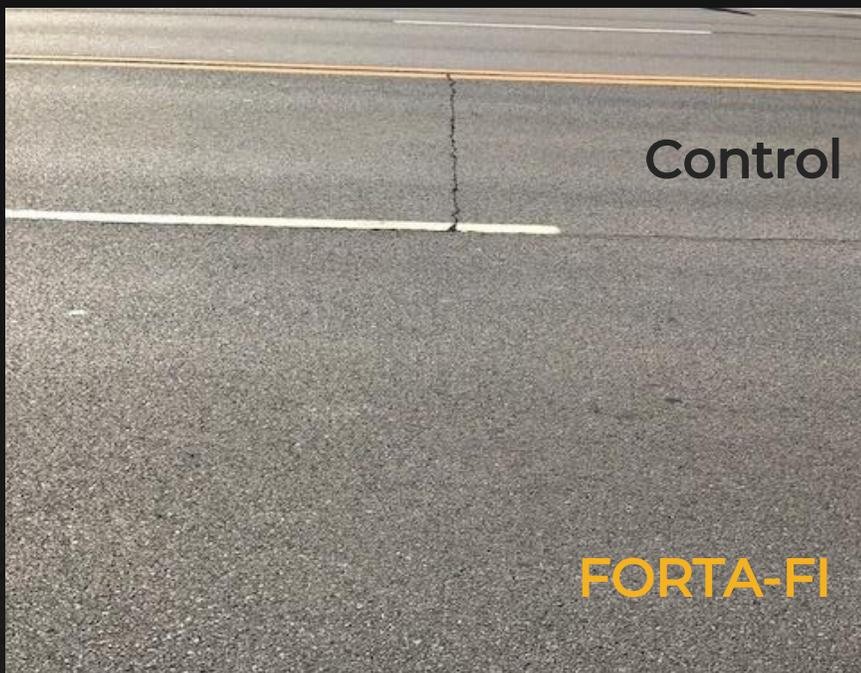
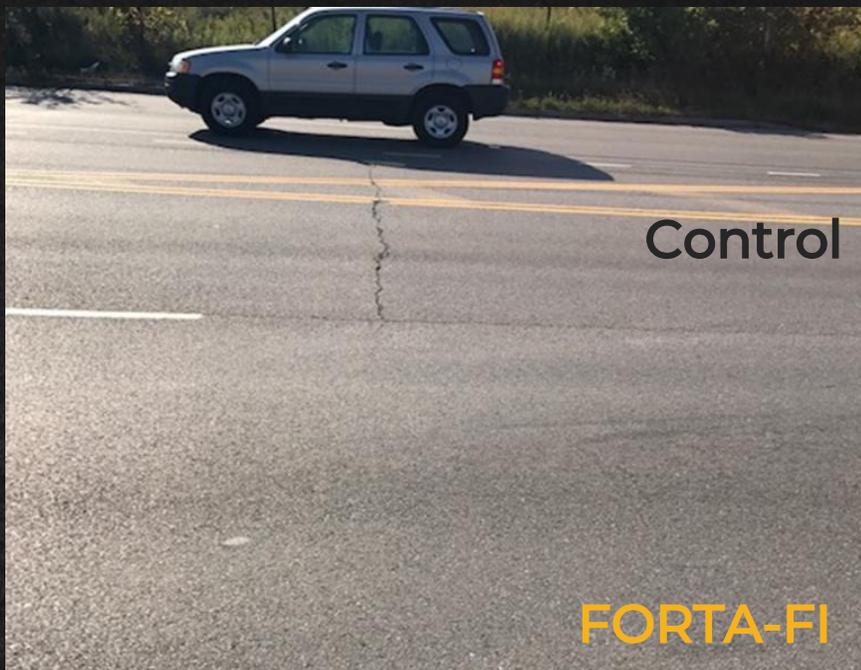
New York DOT Control vs Fiber

- **Control**
6-in Joint Repair Dig Outs, Polymer Modified Binder (PG 64V-22), 2-in Mill & Overlay
- **Fiber Reinforced Asphalt**
2-in Mill & Overlay, Neat Binder (PG 64S-22)
- **Results**
FRAC section significantly outperformed. Further adoption from NYDOT

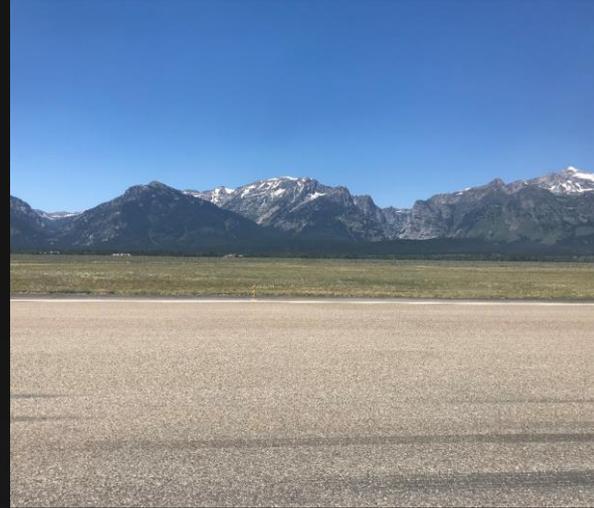
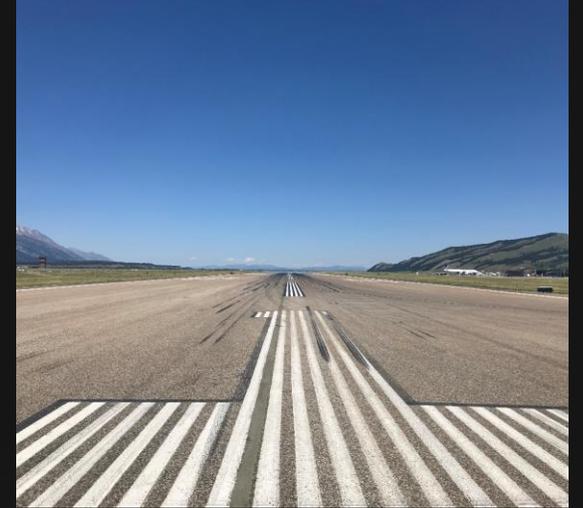
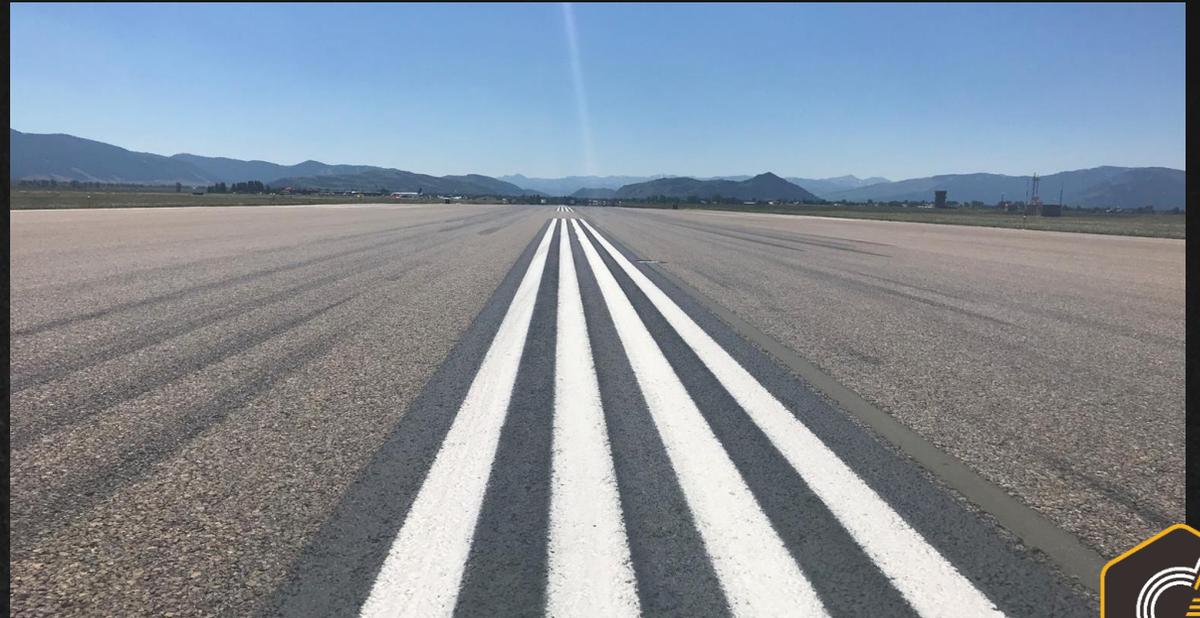
Jackson Hole Wyoming Airport Runway

- **Standard Treatment – Prior to 2009**
6-7 yr Lifespan, Maintenance Every 2-3 yrs
Failures attributed to high dynamic loading, locked-wheel turning, and extreme environmental conditions
- **Fiber Reinforced - 2009**
12+ yrs Lifespan, Maintenance – 1 Application
- **Condition Survey Completed by NCE, 10 yrs**

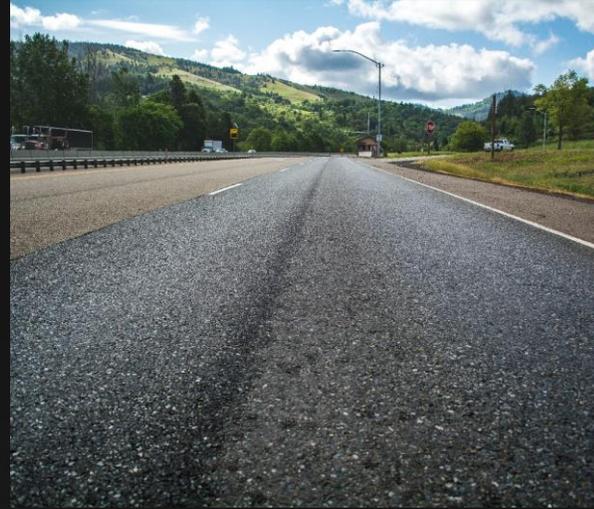
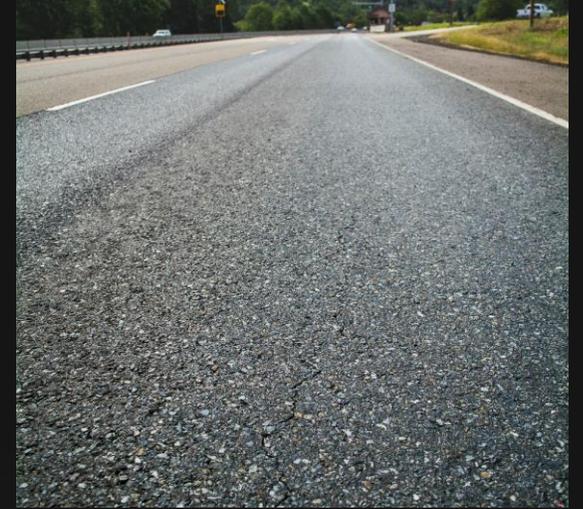
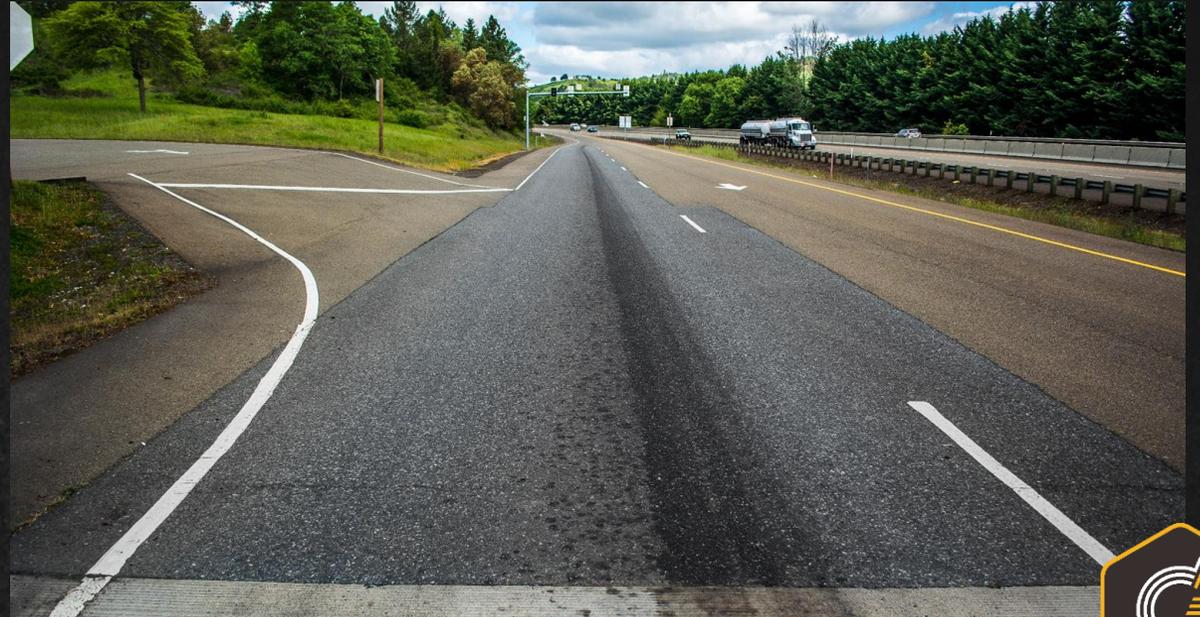
I-5 South Roseburg, OR

- **Standard Treatment – Prior to 2013**
“Replacement needed every 2-3 years” ODOT Maintenance Supervisor
- **Fiber Reinforced - 2013**
8+ yrs, Still in Great Condition

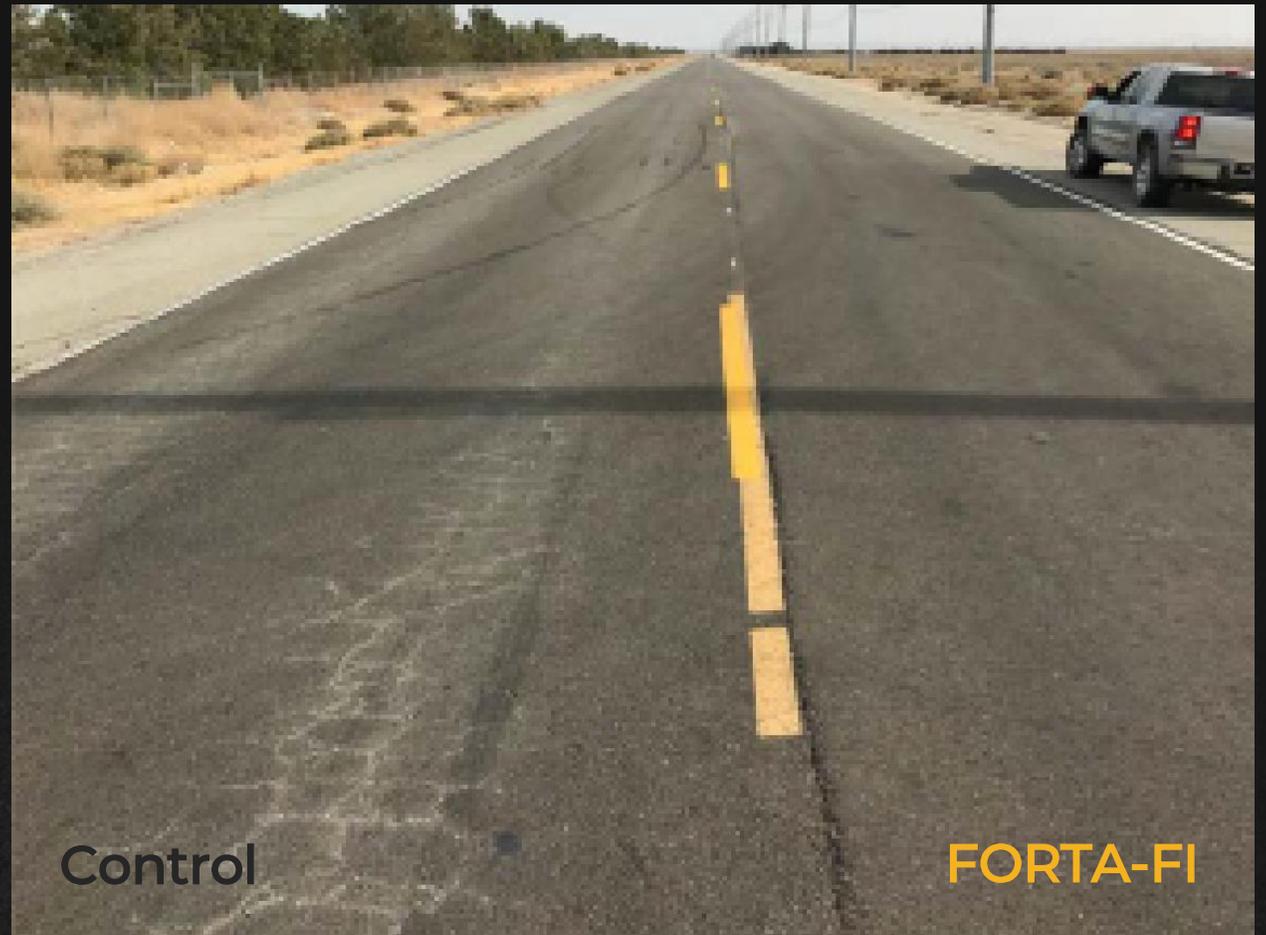
Avenue D Lancaster, CA

- Asphalt Destroyed, Reconstruction Needed
- Despite Warning They Did A 2-in Overlay
- Side-by-side Showed Significant Benefit from Fiber but Still Will Fail
