SEISMICALLY VULNERABLE EXISTING BUILDING FACT SHEET SUMMARY

What is this document?

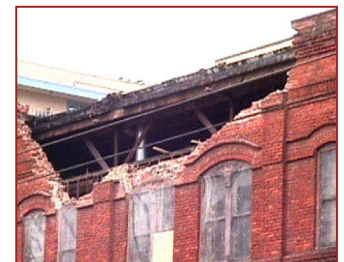
Lack of appropriate connection between roof and wall causing wall failure.

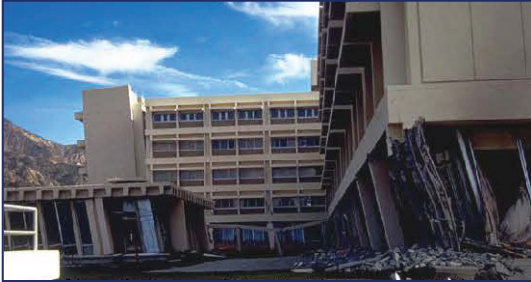
Image of heavily damaged non-ductile concrete building

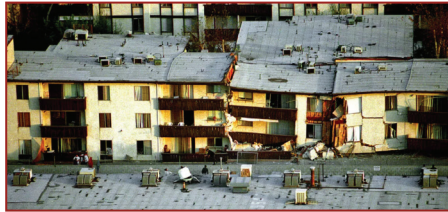
The Northridge Meadows apartment complex first floor collapsed during the M6.7 earthquake on Jan. 17, 1994.³

Nearly collapsed building first floor near Beach and Divisadero Streets in San Francisco during the Loma Prieta earthquake on Oct. 17, 1989.⁴
