Pavement Distress - Slippage Cracks

Minnesota Asphalt
Pavement Association
www.asphaltisbest.com

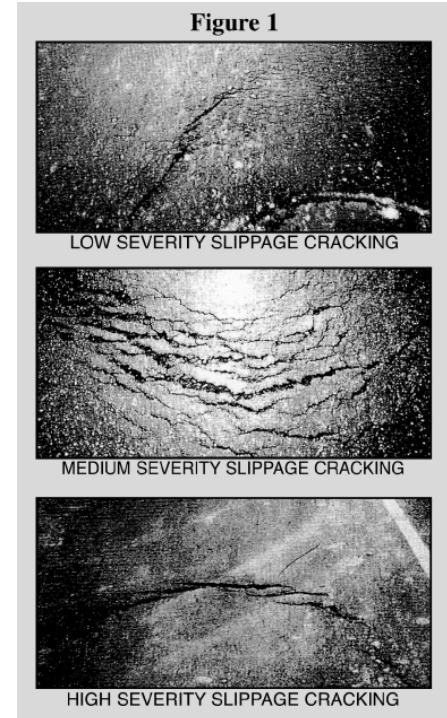
Slippage cracks are crescent-shaped or horseshoe-shaped cracks which have the open end of the horseshoe pointed in the direction of traffic travel. This type of crack, shown below (Figure 1) is caused by shoving of the mix in a forward direction under the wheels of vehicles. The cause of the shoving itself, however, is related to two primary factors – a lack of bond between the surface course and the underlying asphalt layer or excessive deflection of the pavement structure.

Lack of Bond: Due to lack of bond, the asphalt surface course mixture is unable to withstand the shearing force applied to it by the passage of traffic. The mix then begins to shove and move forward. Slippage cracks are usually found in areas where traffic is accelerating or decelerating, since these are locations where the shear force applied to the pavement is the greatest.

Excessive Deflection: Slippage cracks can also be associated with fatigue cracking. In some locations, where the pavement is underdesigned for the traffic using it, excessive deflection of the pavement structure under load will cause alligator cracking of the asphalt layers. The alligator cracking comes from the bottom up. Before the fatigue cracks can reach the surface layer however, the bond between this layer and the underlying course may be broken, due to the excessive deflection. The surface course will then slide or shove, resulting in a slippage-type crack.

Repairs: The type of repair needed is dependent on the type and severity of slippage crack. For slippage cracks caused by a lack of bond between pavement layers, it is necessary to remove the surface course and replace it. The failed area should be taken up to the point where a good bond is found between the old and new pavement courses. The exposed surface should be thoroughly cleaned and made free of foreign debris (i.e. dust, oil, sealant, etc.). Next a tack coat should be applied to the old surface. For deflection or fatigue related slippage cracks, complete pavement removal and replacement is needed. Thicker lift thickness, especially the wear course layer, as opposed to a multiple series of traditional thinner lifts, is also an acceptable repair consideration (i.e. bypasses, crossovers, etc.).
