Tire Scuffing and Indentations of Asphalt Pavement

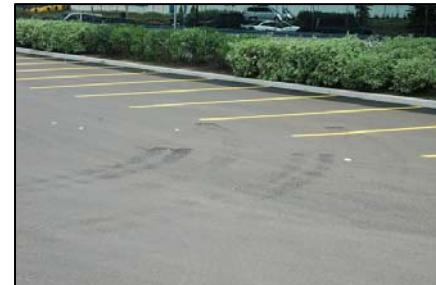
Newly constructed asphalt parking lots or driveways may occasionally exhibit surficial tire scuff marks and indentations particularly when opened to initial or early traffic. The occurrence of these marks (see photo) is often exacerbated during periods of hot or humid weather.

There is no quick fix for scuffing or indentations without possibly causing more damage to the asphalt surface. Most marking will disappear in time under normal traffic conditions. The best approach is to be proactive in considering the facility and use, type of vehicles, traffic patterns, mixture type selection, and immediate usage after compaction of the asphalt pavement. As an example, an application of sand (5-7 lbs/sq.-yd.) to truck delivery areas, compost pads, truck scales, etc., or flooding with water to lower the mixture temperature has been successfully used to help prevent tire scuffing. Repair methods used should be evaluated to determine the long-term effect of the procedure.
